Manhole Inspection Summary

Manhole # S35II1012MH

Location Address: **212 LAMBETH RD**

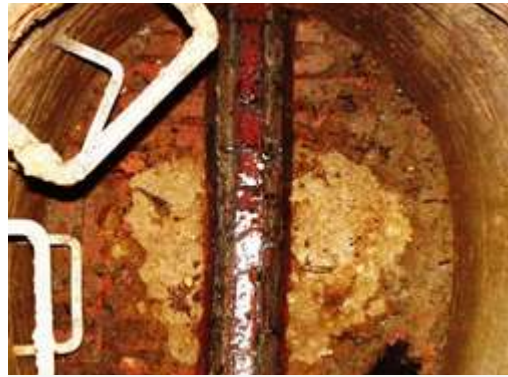
Top View

Bench debris.

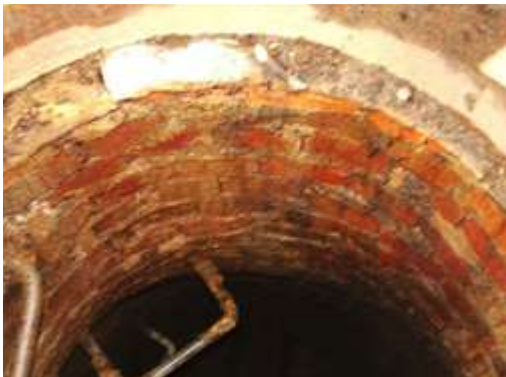
Defect

Condition: ☐ Sound ☐ Cracked ☐ Root Intrusion ☒ **Loose Brick** ☒ **Deteriorated**

Infiltration: ☐ None ☒ **Joint** ☐ Cracks ☒ **Mortar** ☐ Roots ☒ **Wall**

Frame offset. Adjustment deterioration, loose brick and infiltration. Corbel and Barrel infiltration.

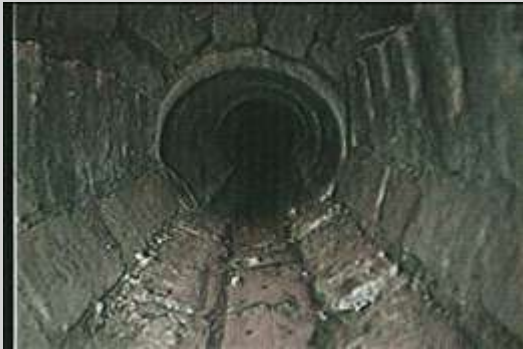
8 in. Circular Gravity Sewer Pipe Out @ 12 O'Clock

Infiltration: **None** Pipe Seal Cond: **Cracked**

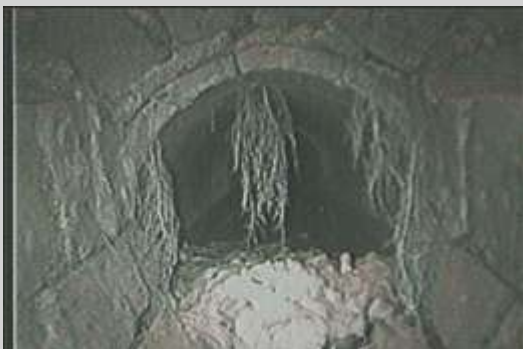
8 in. Circular Gravity Sewer Pipe In @ 6 O'Clock

Channel deterioration.

Deposits: ☐ None ☐ Mud ☐ Sludge ☒ Debris ☒ Grease

Silt Depth: **2** (in.) Deposits Extent: **Medium**

Infiltration: **Evidence** Pipe Seal Cond: **Roots**
